**Big Bald Lake
Stream and Wetland Investigations**

(July and September 2011)

Prepared by:
Snider's Ecological Services
14 Daniel Court
Lindsay ON
K9V 5M3
705-328-3073

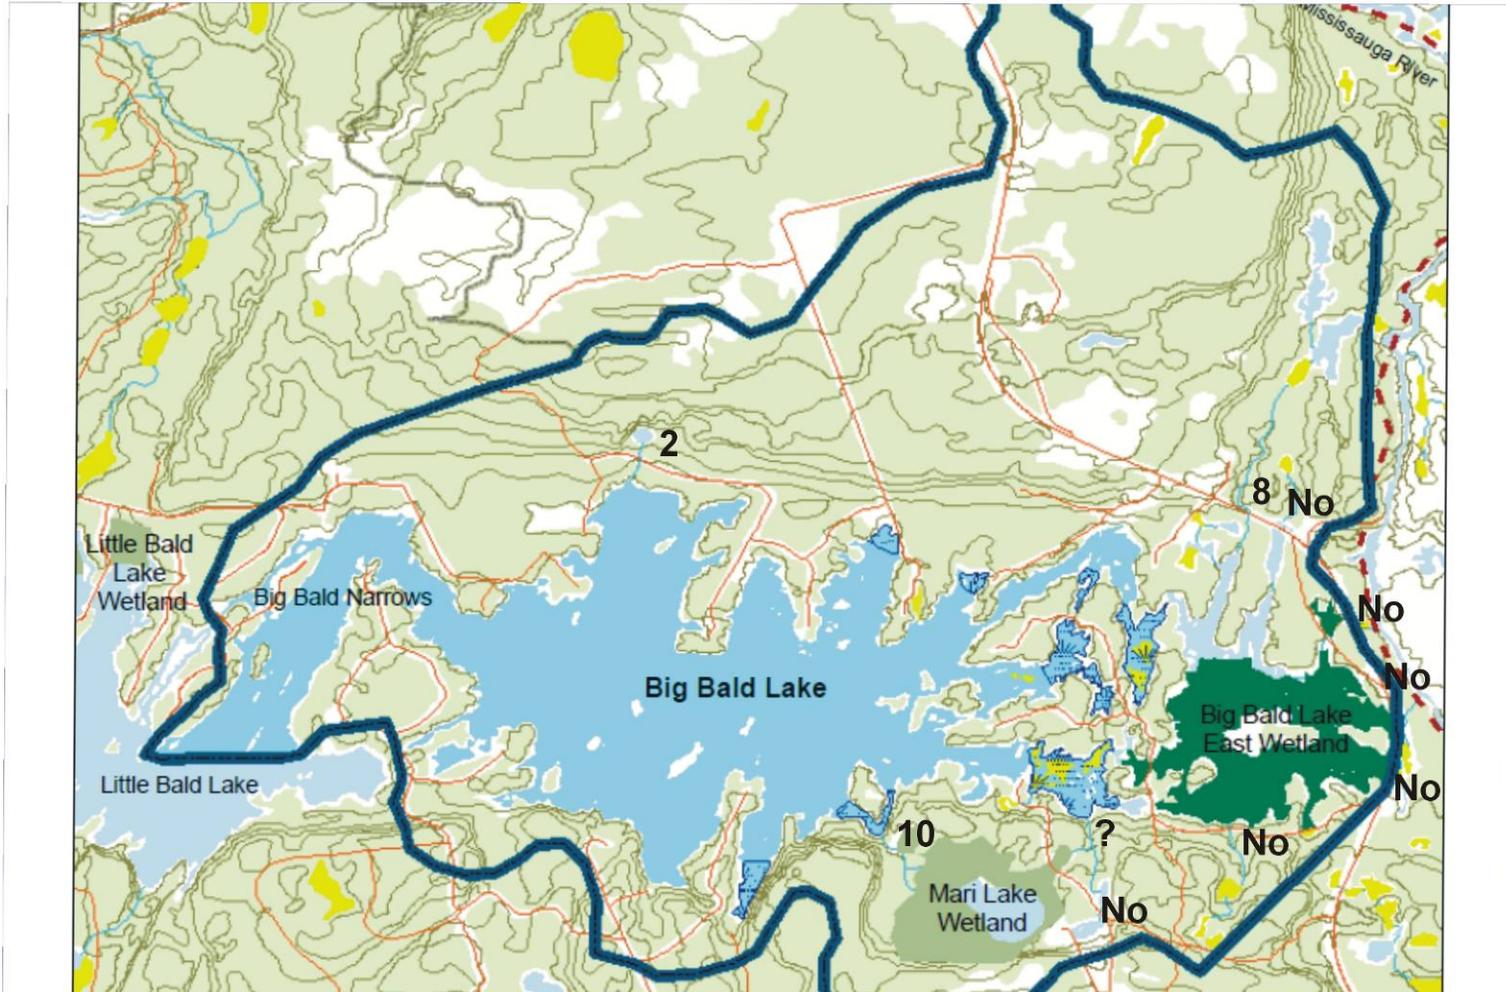
Map 1. Big Bald Lake Watercourses Previously Identified by Photo Interpretation

Numbered streams refers to streams identified on map and verified in field.
Streams marked with “No” were found not to exist.

Nine streams are shown on the Ontario Base Map (OBM) (Map 1, page 10) as flowing into Big Bald Lake or the Big Bald Lake East Westland but these had not been ground proofed. Eight of these streams were investigated in the field. Five of these 8 mapped streams investigated were found not to exist and three were found to exist. This shows the difficulty of relying on air photo interpretation for identifying very small streams. Field investigation is essential. One OBM mapped stream was not investigated and this stream is shown on Map 1 (marked with a '?') flowing into the south east side of Big Bald Lake that was found to be inaccessible.

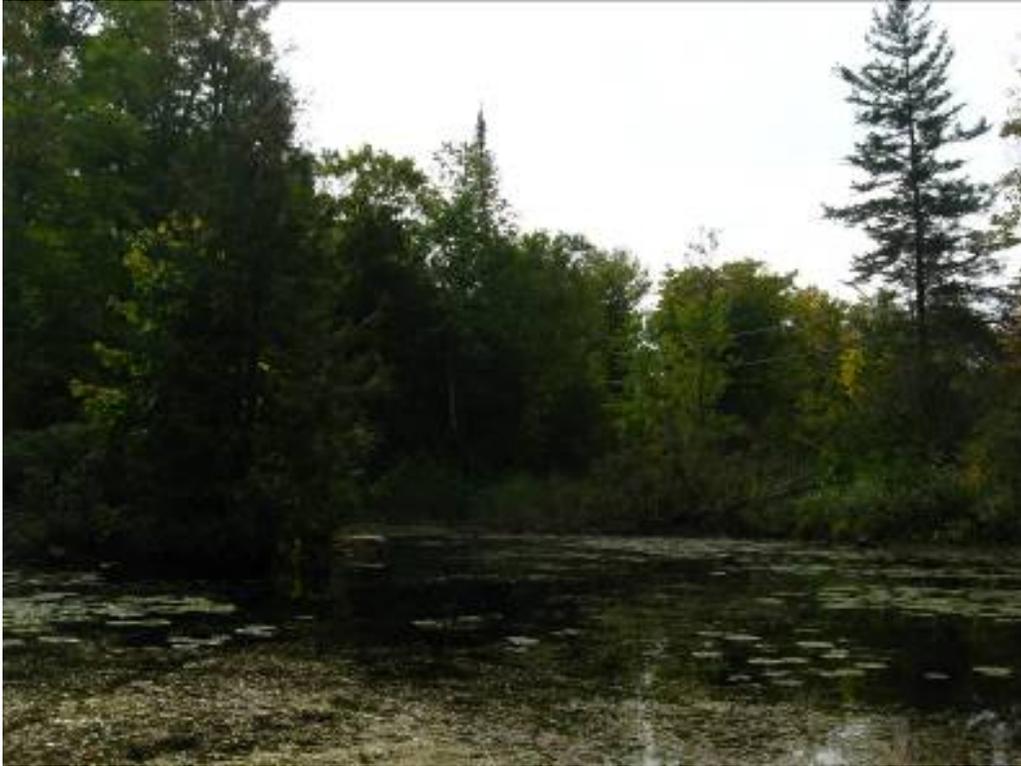
Stream 1. Stream opens into small marsh wetland.

Stream 1 - This stream flows through property 1958 (911 number) and across FR 89 into Big Bald Lake. The access road (FR 89) appears to dam up a treed swamp wetland that empties out through a culvert into the lake. Thus stream 1 is an exceedingly short stream and is more an outlet than a linear feature.

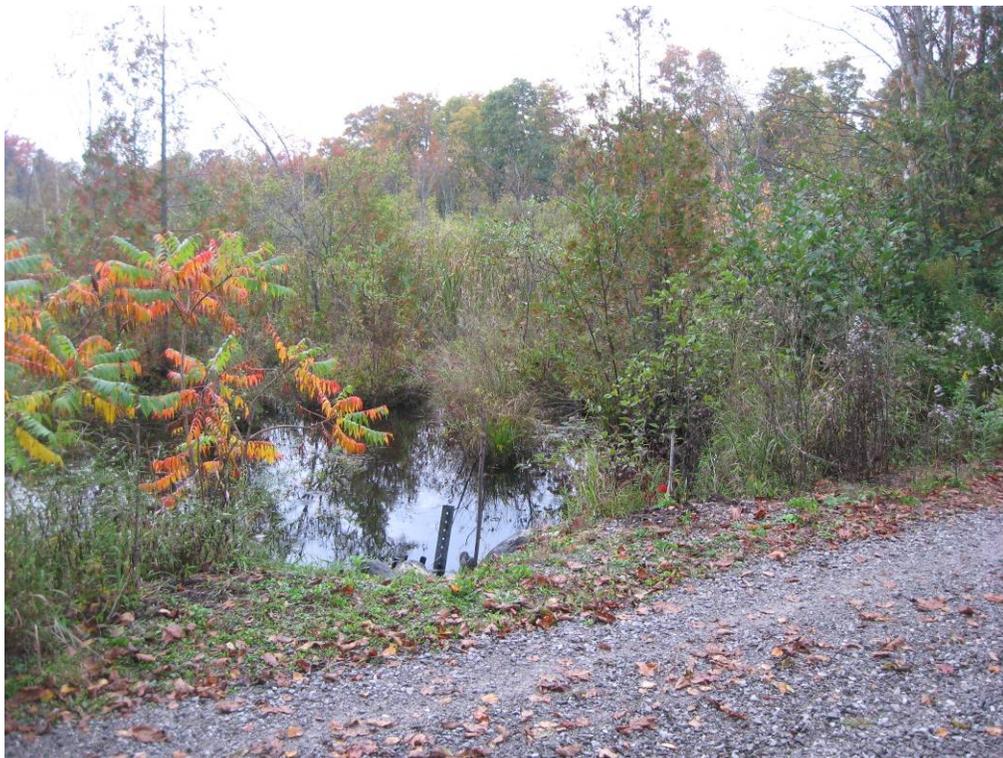
Stream 1. Looking upstream from road and location of culvert into treed swamp

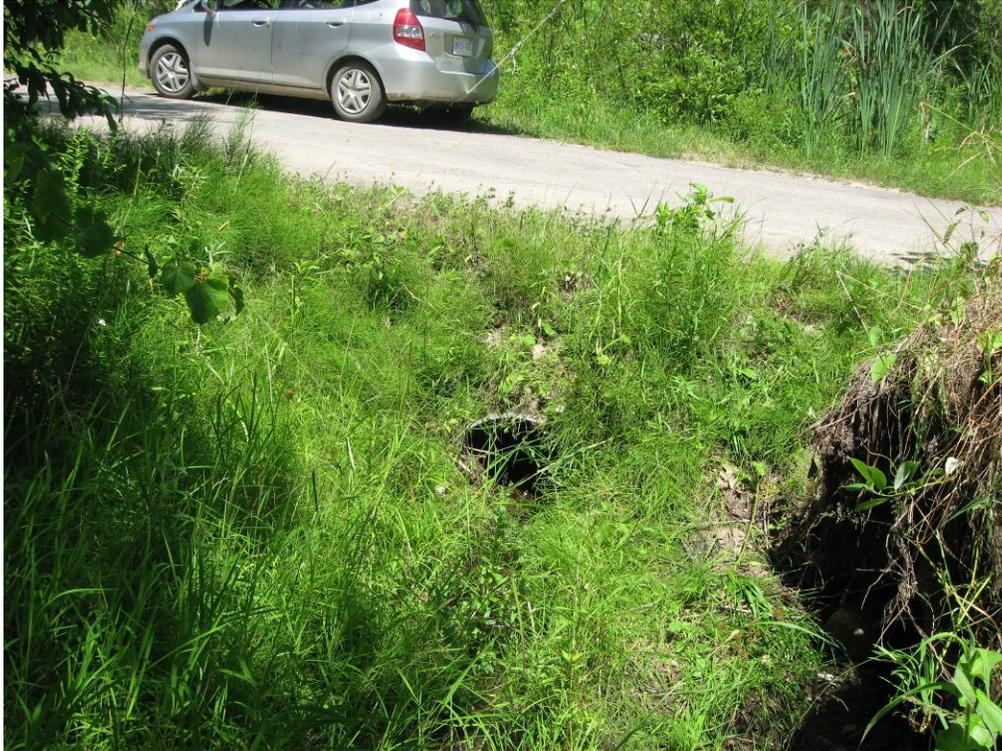
Stream 2. As it crosses Philrick Dr.

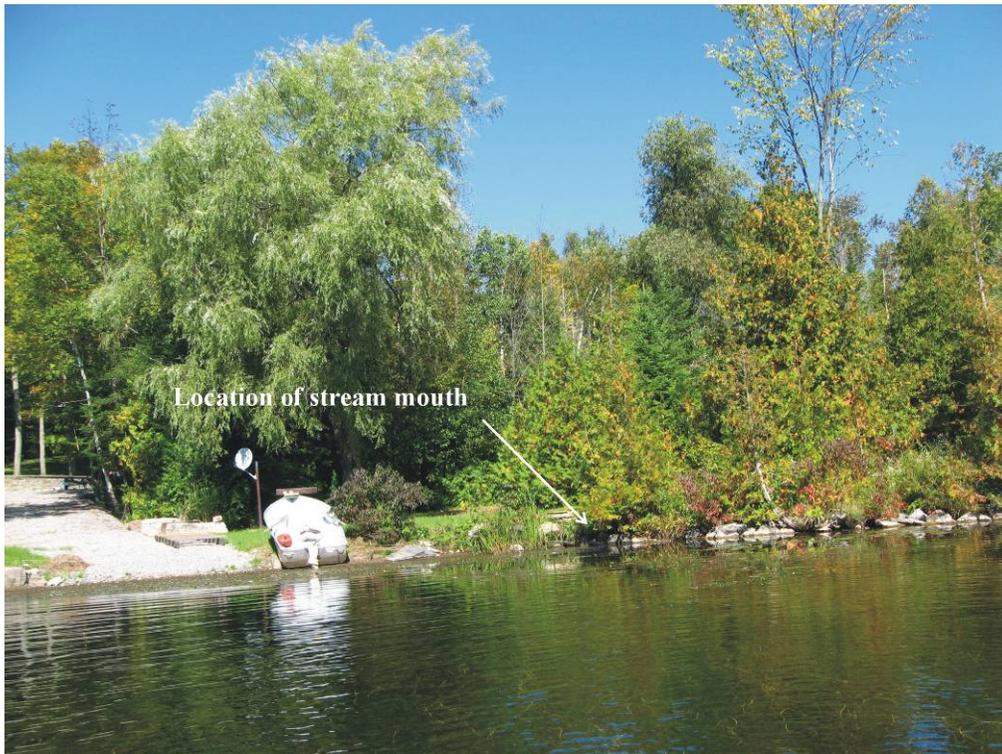
Stream 2. Stream enters lake near cottage.

Stream 2 - This is one of the larger identified streams with an estimated flow of 10 to 20 gal per minute. The stream flows through property 1709 and enters the lake through a treed swamp. This is a marginally warm water stream and this probably is a result of this stream originating in a pond about 60 m inland from where it crosses Philrick Dr. Stream 2 enters the lake in a wetland area but is within 2 m from cottage lawns on its west bank (see photo of stream 2).

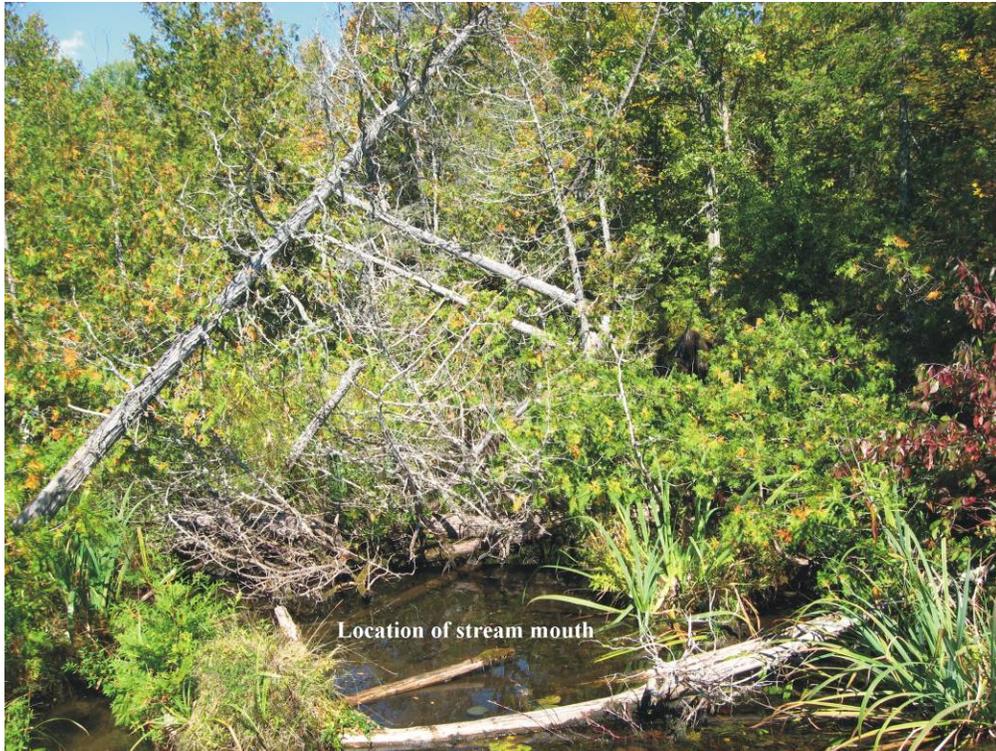
Stream 3, 4. Stream mouth exiting through treed swamp.

Stream 3 and Stream 4 - These streams are separate as they cross Philrick Dr. but join a few meters downstream. These streams flow through property 1709. Stream 3 is a coldwater stream and stream 4 is a cool water stream. The combined stream flows through a swamp to reach the lake. The swamp protects the stream from shoreline development with about 6 m to the lawn on the east and 56 m to the lawn on the west.

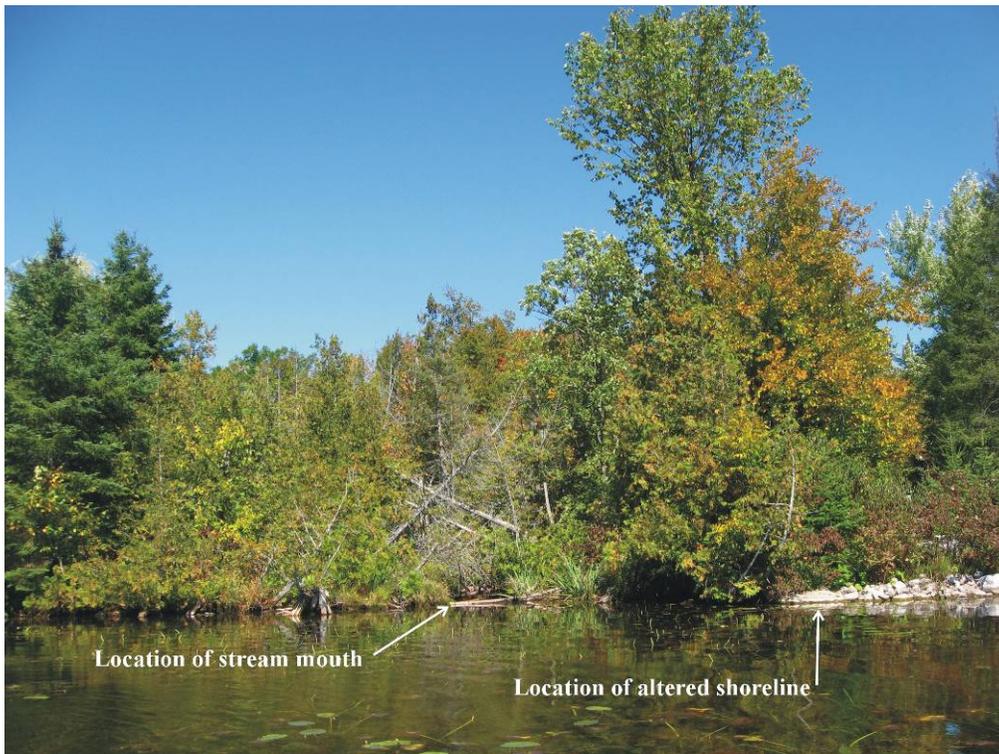
Stream 3, 4. Stream mouth showing adjacent hardened shoreline.

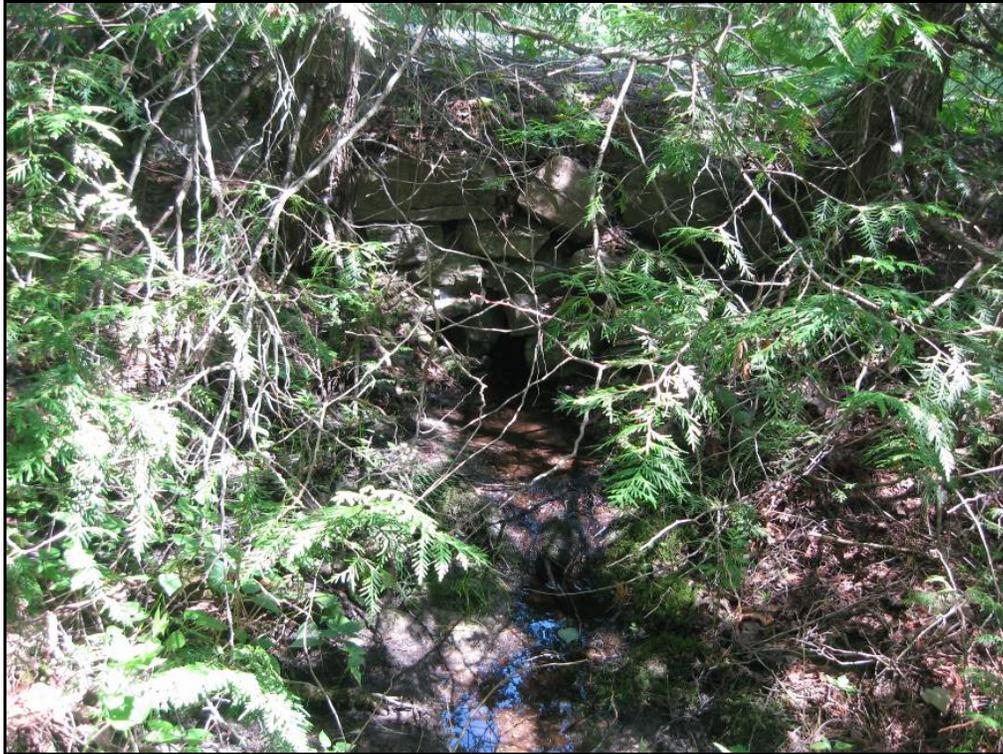
Stream 5. A small cold water stream looking upstream to culvert.

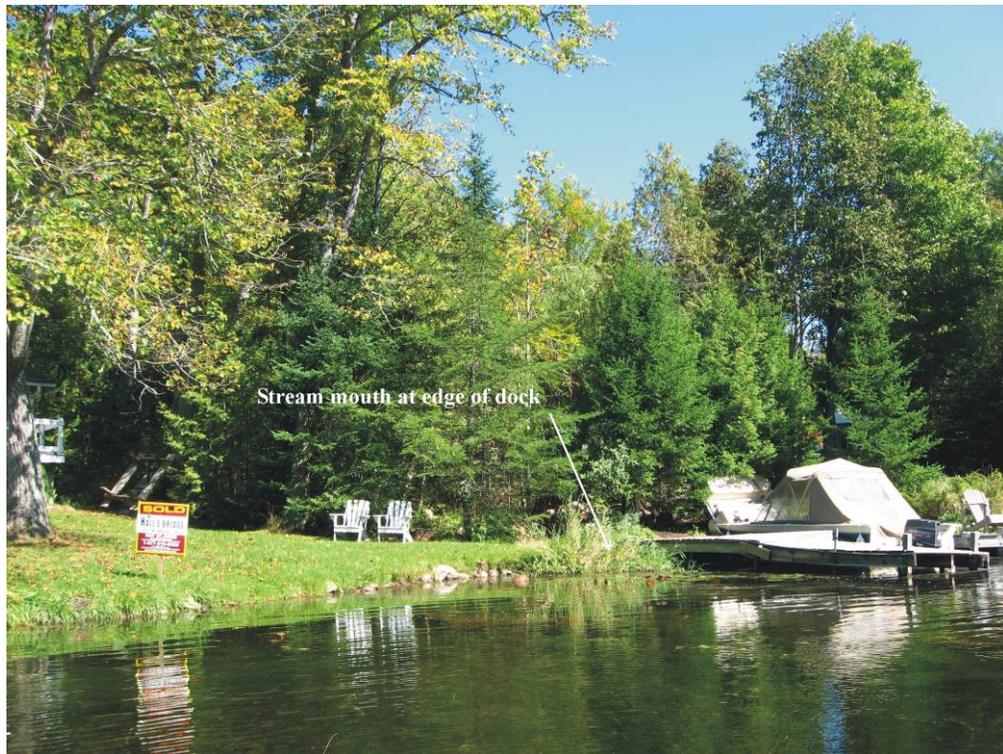
Stream 5. Stream mouth located right at edge of dock

Stream 5 - This is a very small cold water stream that flows through property 1767. It flows through a sugar maple dominated hardwood bush and enters the lake right at the corner of a waterfront dock (see photo of stream 5). The lack of wetland appears to have lead to less protection of the stream.

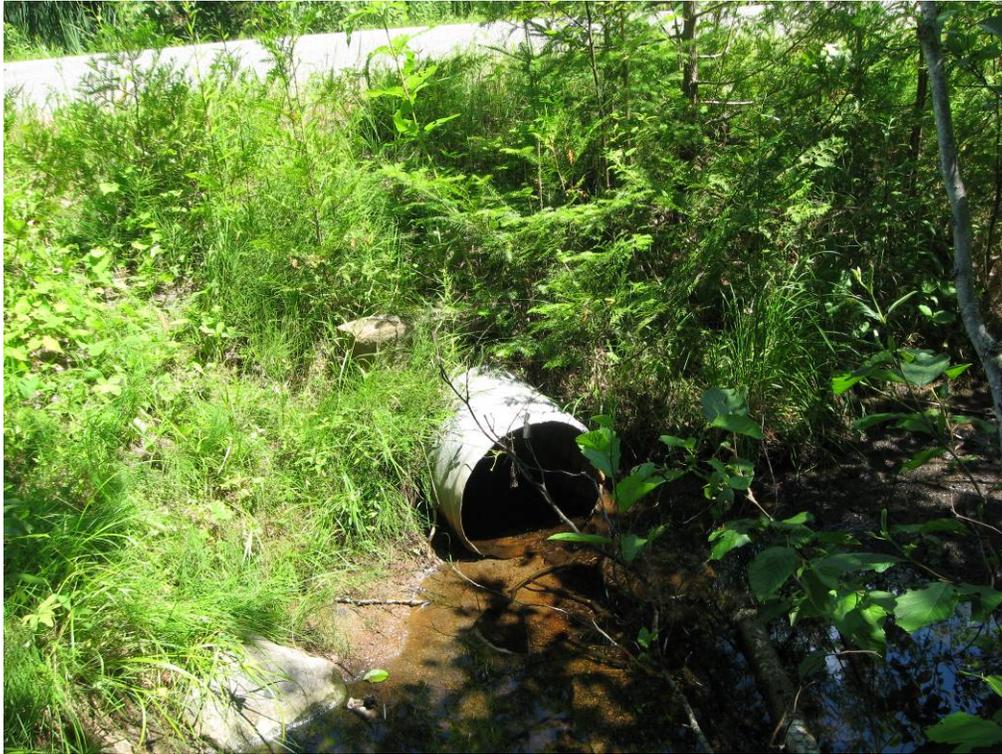
Stream 6. Stream through culvert on Philrick Dr

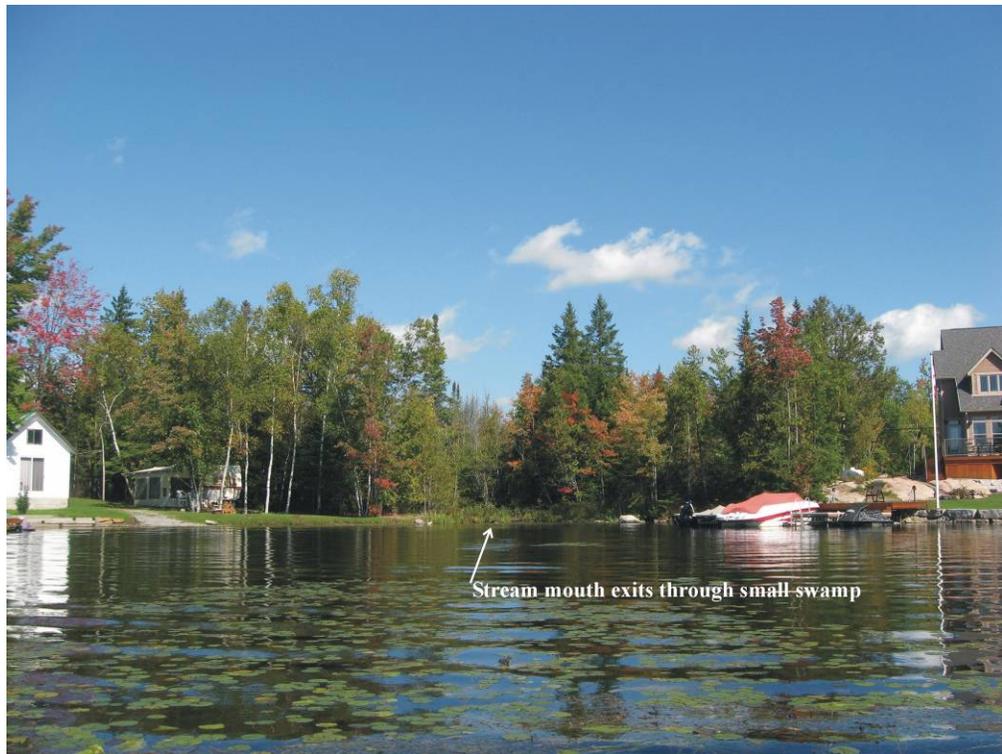
Stream 6. Location of stream mouth.

At the stream mouth a stone wall is located about 2m to the east and a lawn is located 8 m to the west. The stream is located in a dense cedar swamp wetland from Philrick Dr. to the lake.

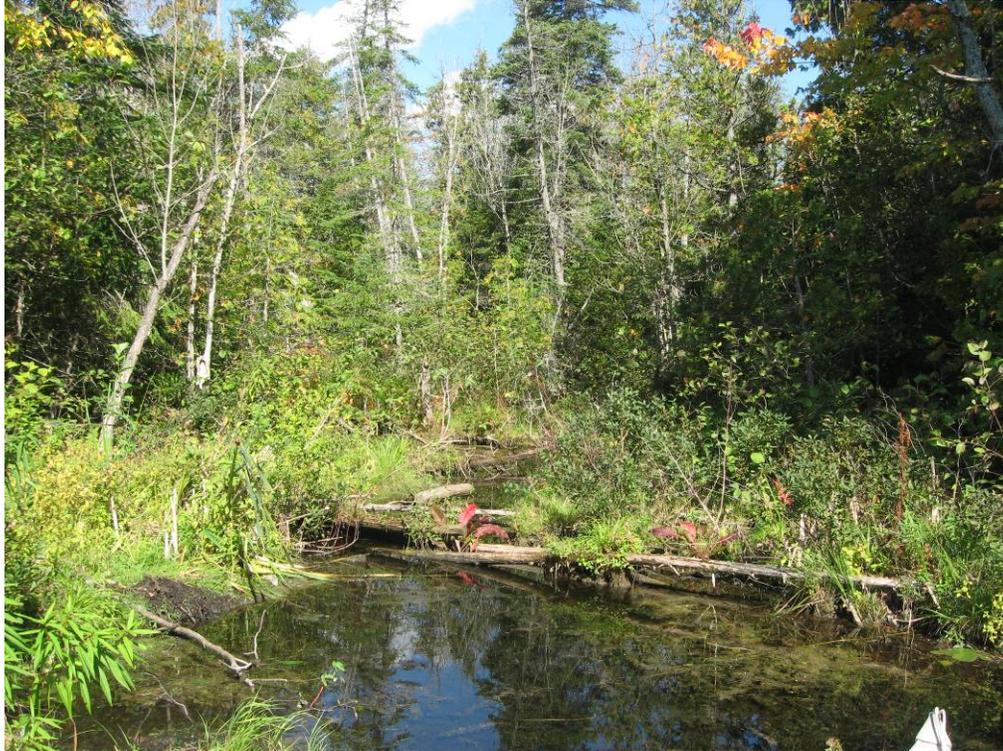
Stream 6. Stream mouth enters lake through a treed swamp

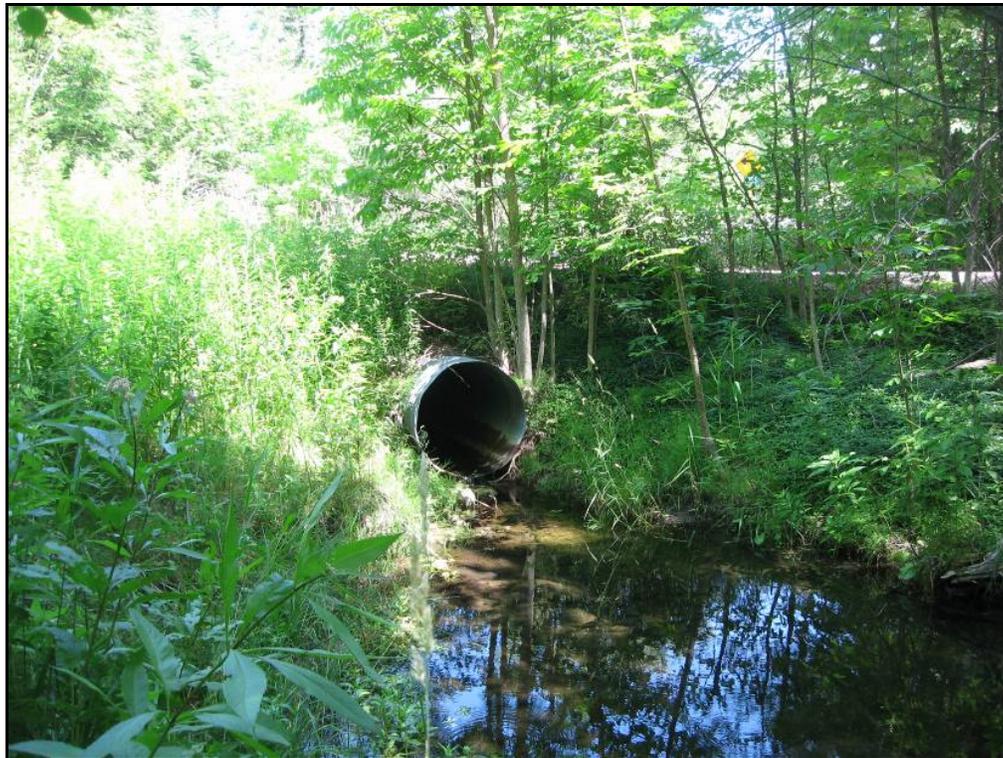
Stream 7 - Stream 7 is a cold water stream that flows about 110 m from-Philrick Dr to the lake. The culvert was perched about 10 cm which could impede fish movement upstream. Small minnows were seen just below the culvert.

Stream 7. A cold water stream with a 36 inch diameter culvert.
Note perched culvert a potential barrier to fish movement.

- In this investigation two culverts (streams 7 and 8) were found to be improperly placed causing a potential barrier to fish movement. Stream 8 had an in-stream pond and this would result in thermal pollution that may have tipped the stream from cold water status to cool water.

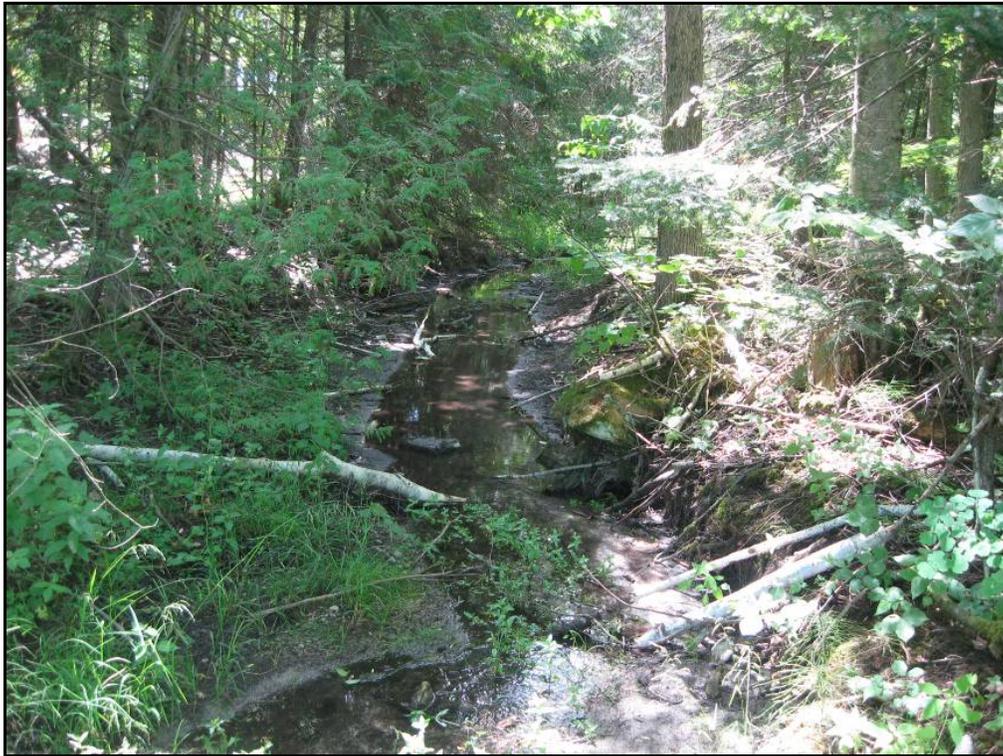
Dragon fly larvae and water striders were seen. The stream for 100 m was about 1 m wide and 5 to 12 cm deep. In portions of this section the substrate on the west side of the stream was clay with silt on the other side of the stream. A short 12 m long section in a clearing had banks with good grass cover with water cress. More open areas had some aquatic vegetation of pond weed (*Potamogeton spp*). A few meters of gravel exist but is a very minor component.

Stream 7 Looking downstream showing watercourse characteristics.
Cyprinid fish were seen here

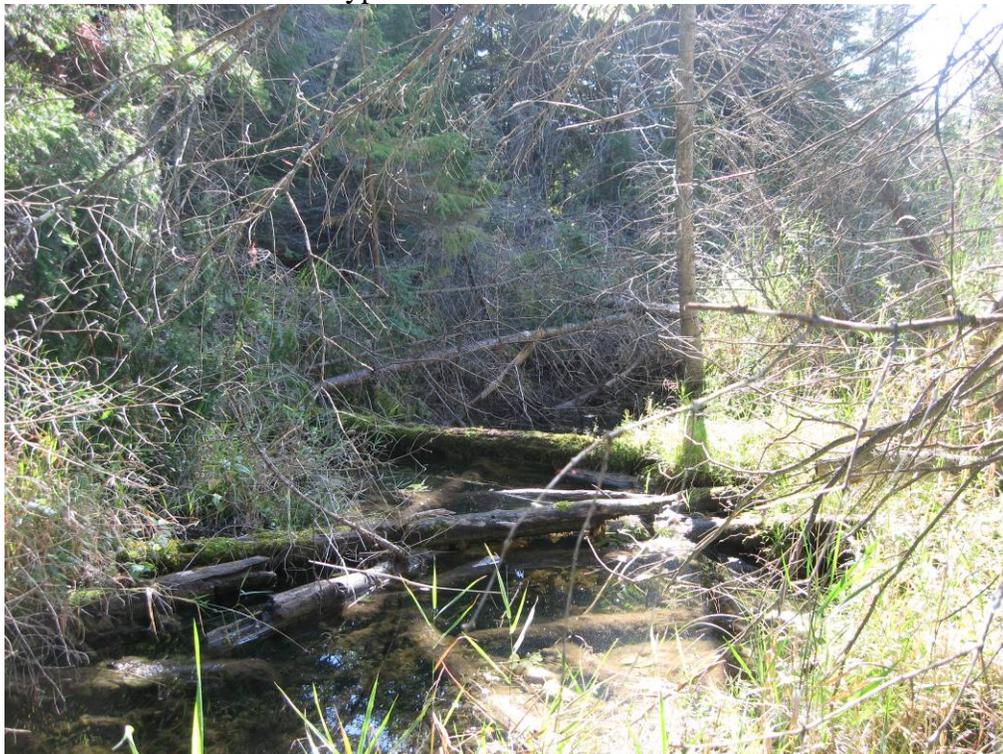
The last section is a 40 m section where the stream slows down and widens out to 3 m width with a thick substrate of silt. This section was blocked by fallen trees. Stream vegetation was mainly crowfoot, pond weed and wild celery. Two painted turtles were seen basking in the vicinity of the mouth of the stream and a male wood duck was seen at the mouth. Shoreline development is located about 45 m to the north and 60 m to the south.

Stream 7. Stream characteristics in the lower section as it slows down and widens out before entering lake.

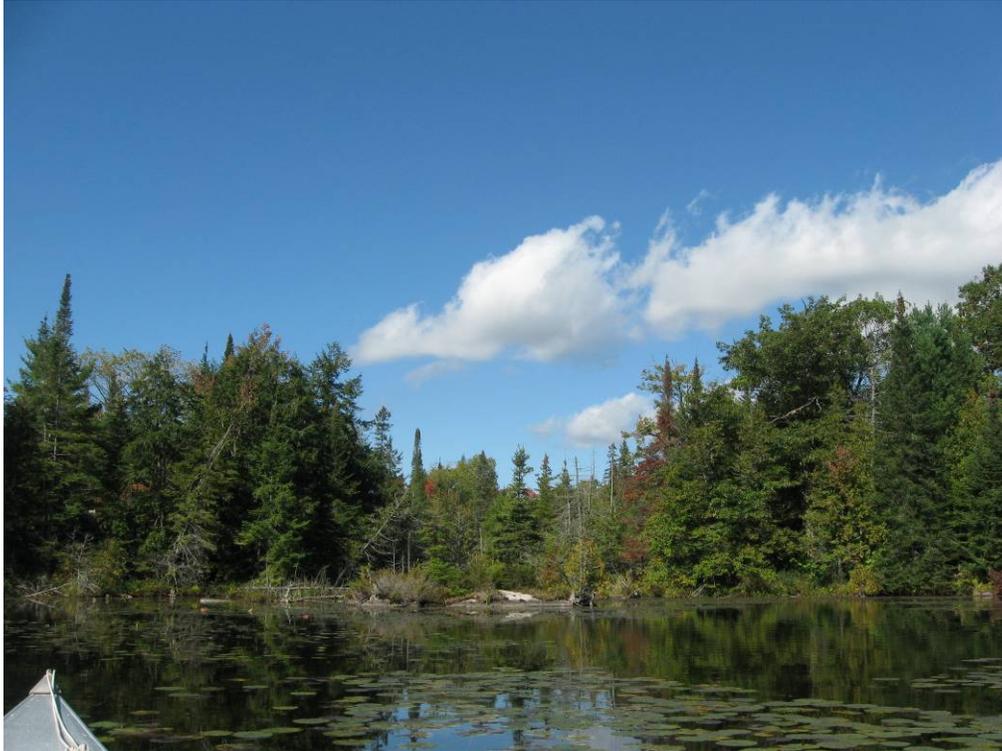
Stream 7. Stream enters lake through a treed swamp.

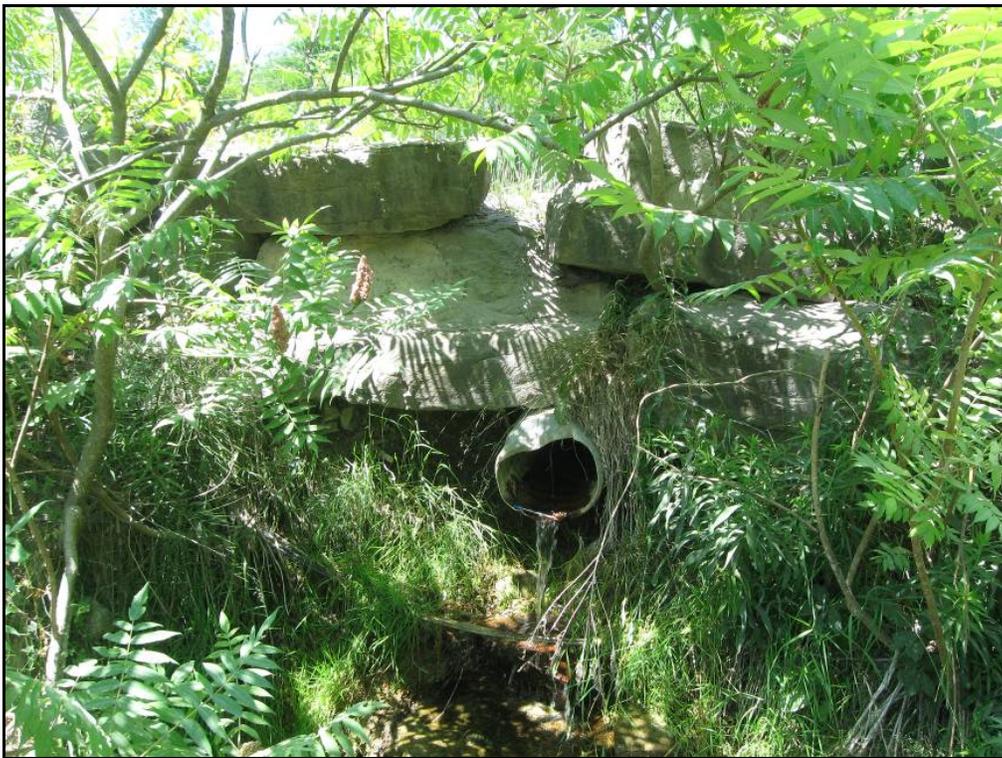
Stream #8. A cool water stream showing a perched culvert a serious barrier to fish movement.

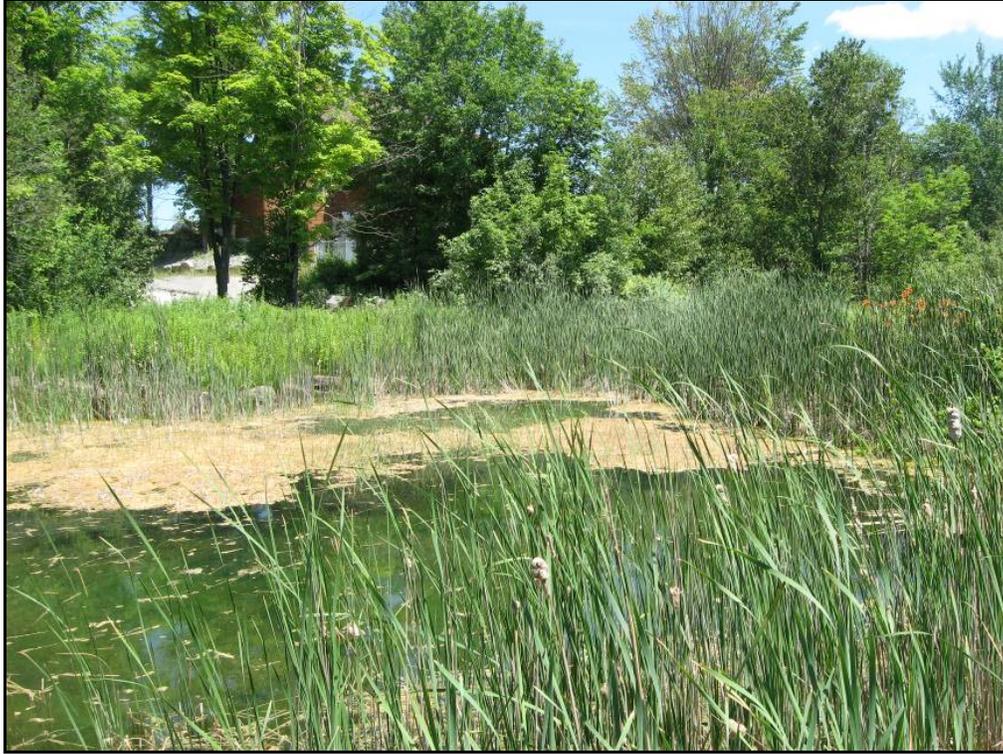
Stream 8 - Stream 8 is located in property 1465. The stream crosses Catalina Bay Road. This stream has an in stream pond just upstream from the Catalina Bay Road

and bass (some that were about 20 cm in length) were seen in this pond. It is assumed that these fish were stocked in this pond. The stream was classed as cool water. The stream flows about 237 m from the culvert through a treed swamp to exit into the lake. In front of the stream mouth is a band of grasses followed by a band of cattails.

Photo 8. Constructed in stream pond. Ponds such as this will increase stream temperatures.

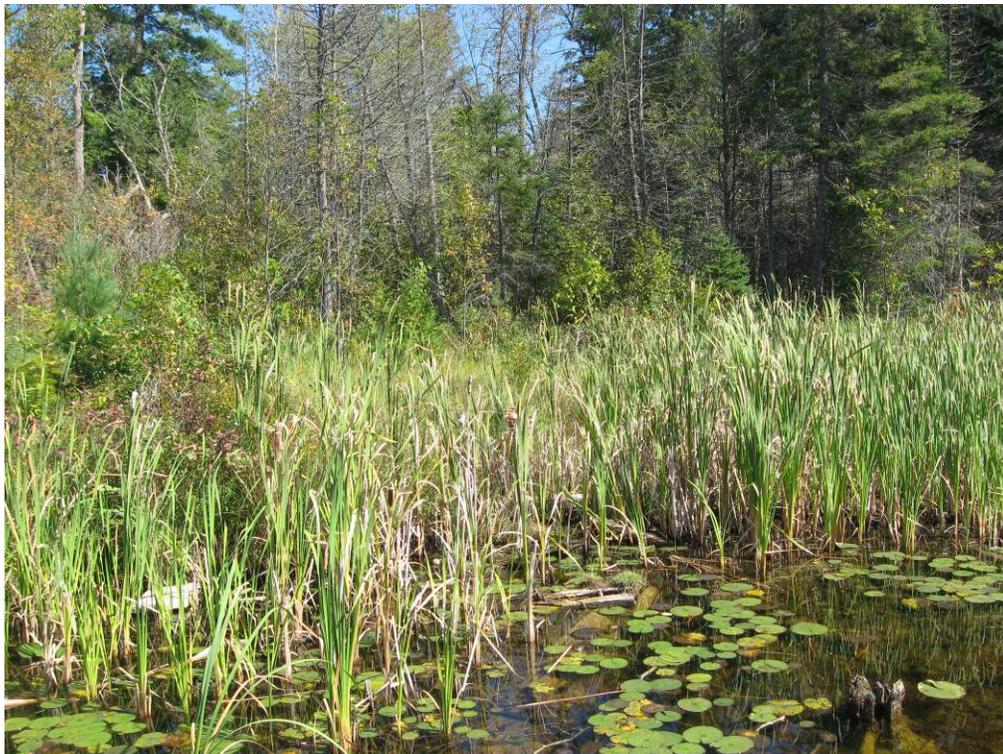
Stream 8. Location of stream mouth in treed wetland with band of cattail and grasses in front.

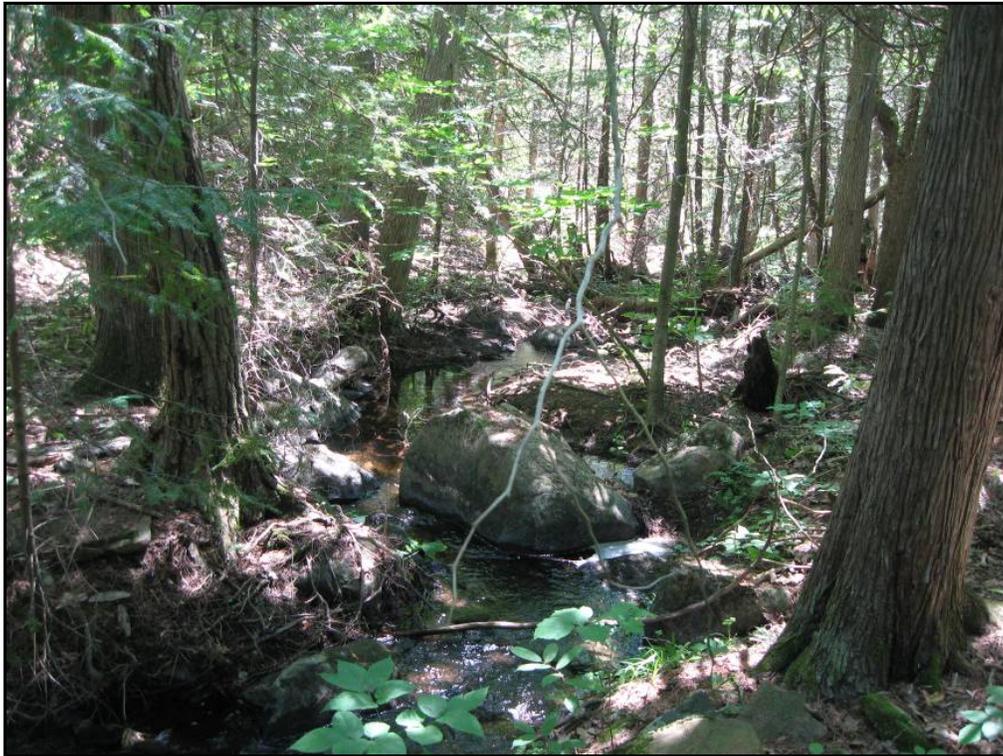
Stream 9. One of the larger cool water streams showing watercourse characteristics.

Stream 9 - Stream 9 flows under Highway 36 and it is one of the larger streams. It is a cool water stream and it flows south into a bay that eventually connects to the Big Bald Lake East Wetland. It was determined that Big Bald Lake East Wetland is hydrologically connected to Big Bald Lake.

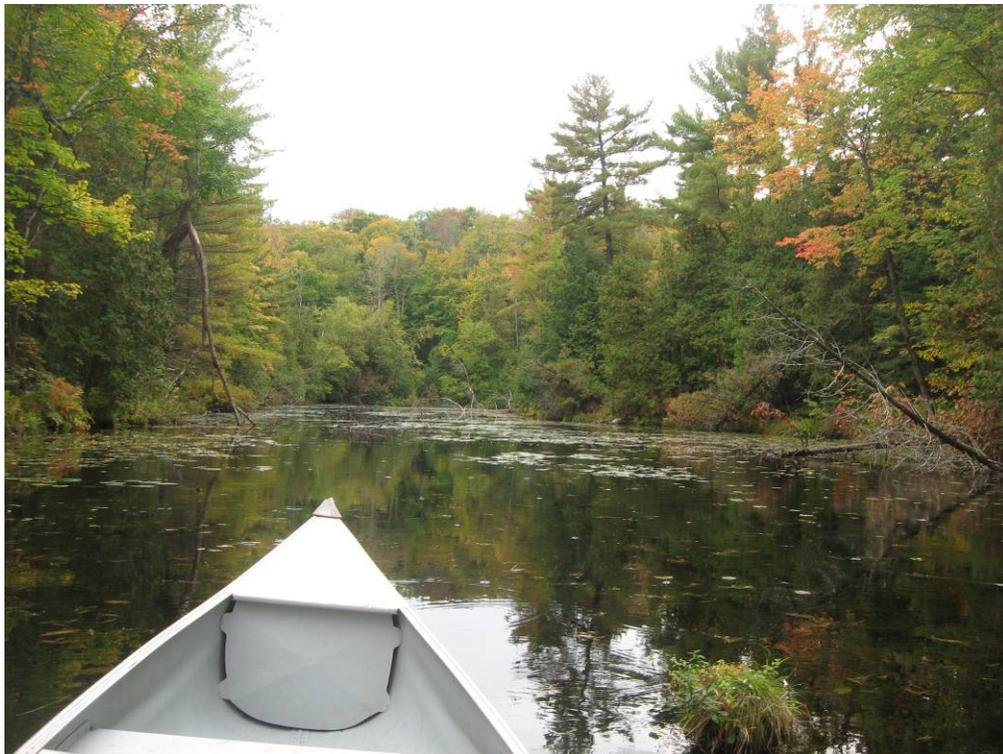
Stream 10. Stream enters at the end of this small bay

Stream 10 - Stream 10 flows out of the Mara Lake Wetland located on the south side of Big Bald Lake. Flowing out of a fairly large wetland the stream is presumably not a cold water stream. The stream was measured to be the largest of the 10 streams investigated with a water flow of about 22 gallons per minute. The stream descends a steep slope through a sugar maple upland forest. The stream is 0.6 m wide and the substrate is mainly rocky material. However the portion of the lake that it empties into is viewed as a lake or lacustrine marsh consisting of submergent vegetation and floating vegetation.

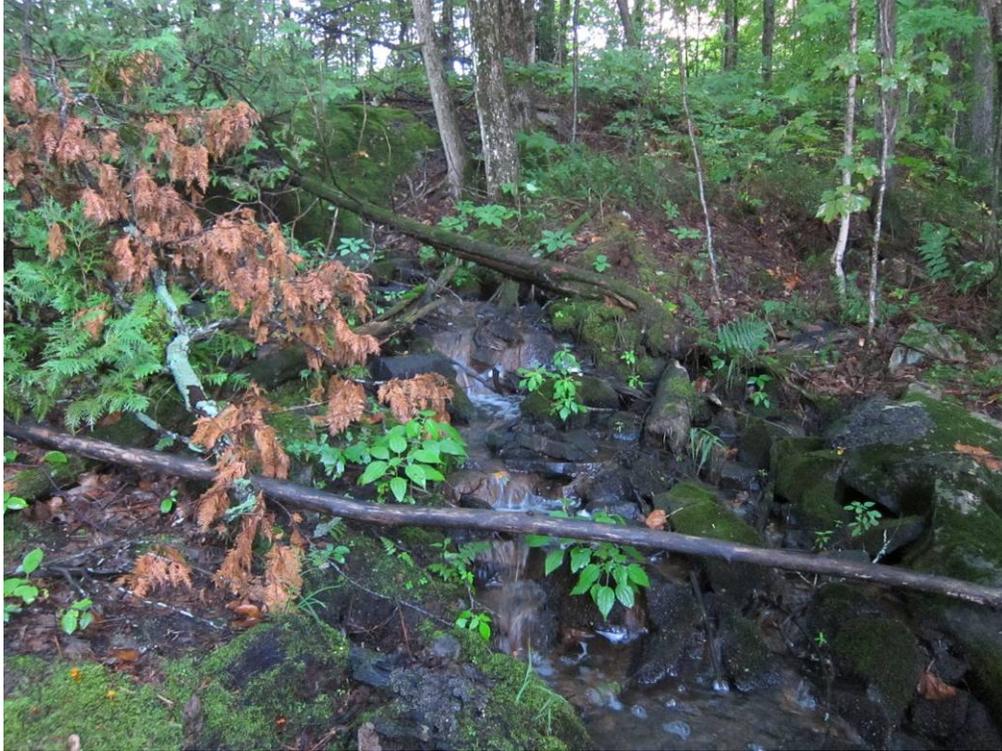
Stream 10. Stream flows down steep hill through hardwood forest
(photo by Susan Lewin).

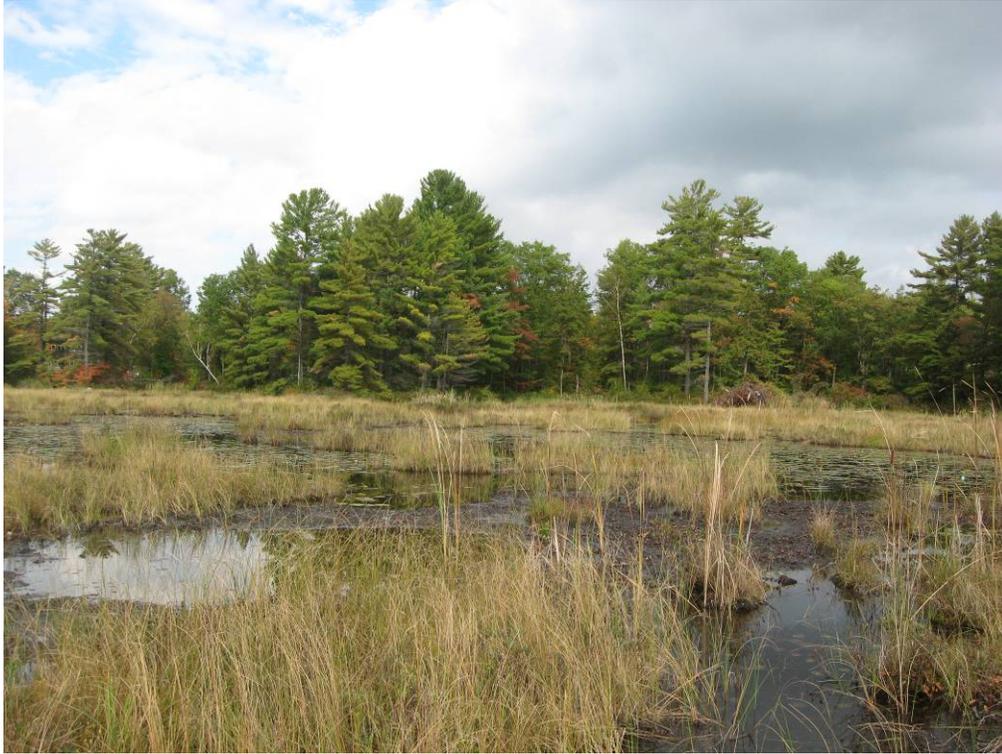
Wetland 1. Wetland on east side of Big Bald Lake showing sedges mixed with small open water areas.

More significant wetlands are located in the eastern part of Big Bald Lake and are shown on Map 3 (page 12). The two larger wetlands that are immediately adjacent to the Big Bald Lake East Wetland, which is a provincially significant wetland, have fen characteristics (photos Wetland 1, 2 and 3) such as wire sedge (*Carex lasiocarpa*) and other fen plants. Fens usually develop in areas of restricted drainage with low oxygen levels and are usually dominated by sedges located on peat.

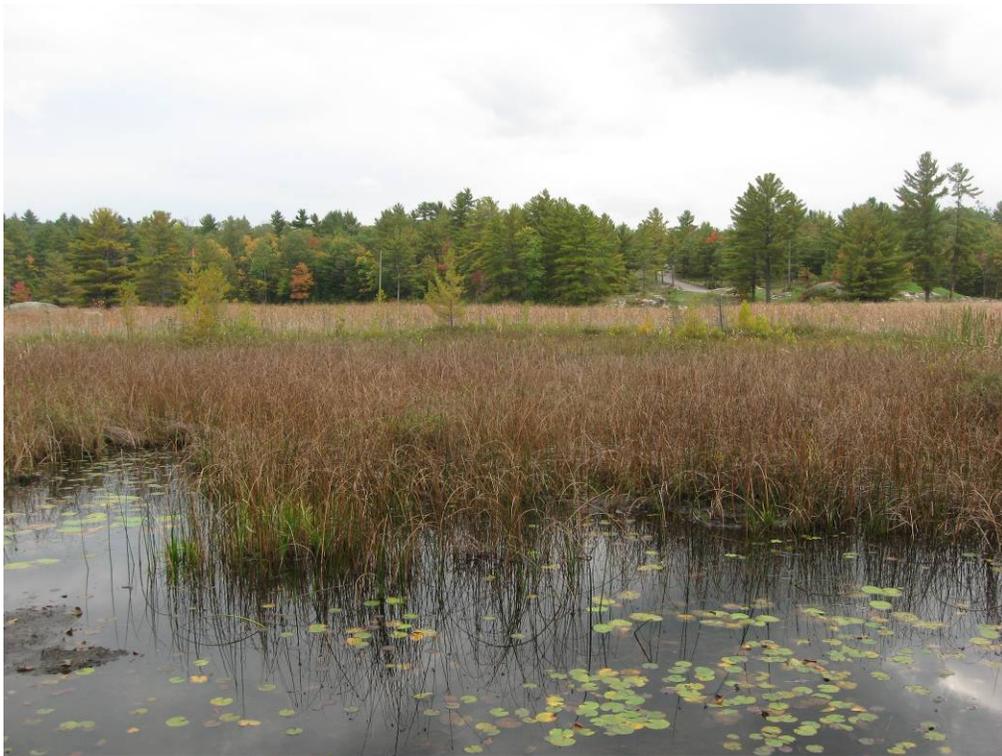
Wetland 2. Wetland on east side of Big Bald Lake showing fen characteristics.

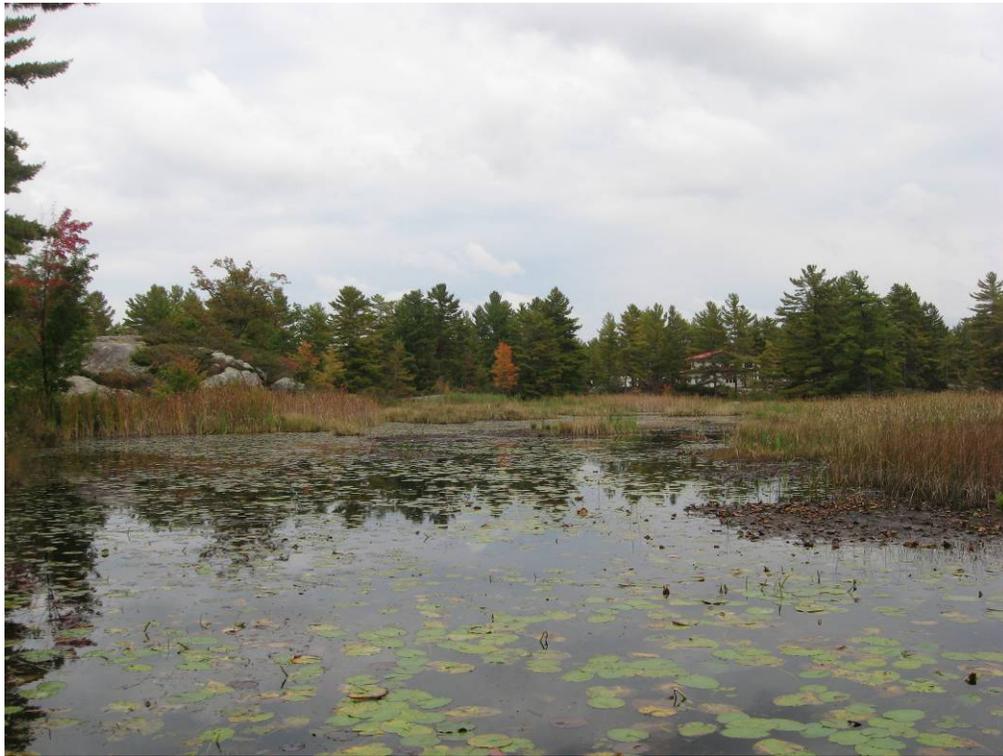
Wetland 3. Wetland on east side of Big Bald Lake showing shallow water marsh mixed with sedge habitat.
